BELZONA RESTORES LOCAL BANK

Bank, Scotland

Window sills, lintels and the external walls of the bank.

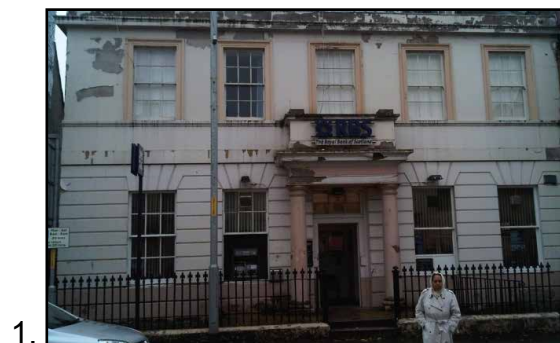
Age and the effect of weather had caused serious deterioration to the buildings facade.

1. Fascia of the building prior to application
2. Damaged Column
3. General view of the completed application
4. The refurbished bank entrance

Application was carried out in accordance with Belzona Know-How System Leaflets WPA-1 and WPA-4. The defective external wall coatings were removed. Some of the broken profiles around the windows and the lintel above the front door were repaired with Belzona® 4141. Belzona® 5151 was then applied to the stonework to protect the surface from further damage.
