## BELZONA INCREASES EFFICIENCY OF COOLING WATER PUMPS

Steel Mill, Hungary

January 2010

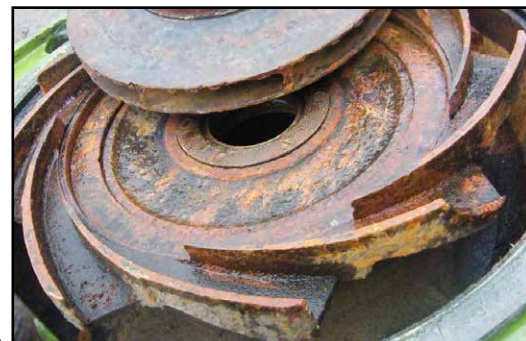
Traces of cavitation, corrosion damage as well as material loss found on the wetted surfaces of the pump. It was necessary to rebuild and coat the inlet, casing and suction cover with Belzona erosion-corrosion resistant products to restore efficiency.

1. Before application
2. After grit blasting
3. Rebuilt and coated pump
4. Finished application
