BELZONA PROTECTS CYCLONES

Cyclone used to dewater drilling mud produced by tunnel boring machine.

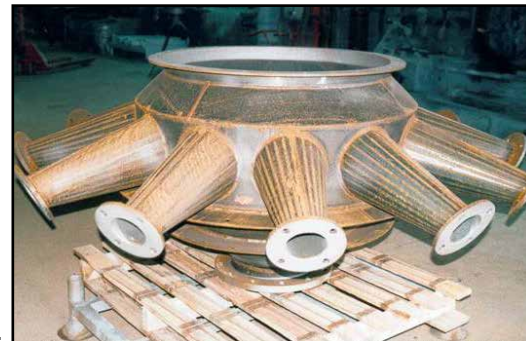
Severe abrasion due to the wet mud. The original bonded rubber lining usually used is difficult to repair insitu due to the complex surface geometry.

1. Cyclone head
2. Interior of the cyclone after blasting
3. Interior of the cyclone after the application of Belzona® 1812

The Belzona solution allowed repairs to be done in-situ minimizing delays to the tunnel boring process. The Belzona® 1812 was easily applied and formed to the complex shape of the centrifuge. No further repairs were required after 2 years in service (2003).
