## SCOOP TRAM WITH DAMAGED PIN BEARING BACK IN SERVICE WITH BELZONA AFTER ONE DAY

Salt mine, Germany

Scoop tram operating in salt mine.

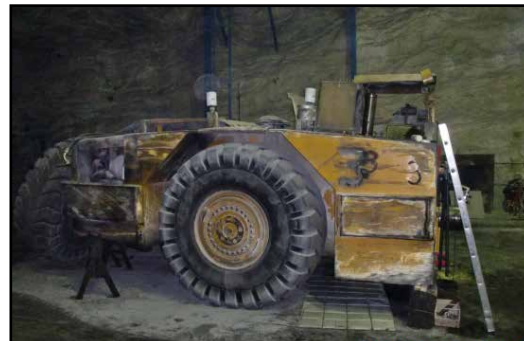
The severe corrosive and abrasive service conditions had led to metal loss on the articulated joint bearing pin, resulting in a relatively short life of the component.

1. Scoop tram before application
2. Injection of the Belzona material
3. Completed application
4. After reassembly of the bearing
