BELZONA KEEPS DUST SUPPRESSION BOWSER IN SERVICE AT QUARRY

Limestone quarry, SW, England

September 2012

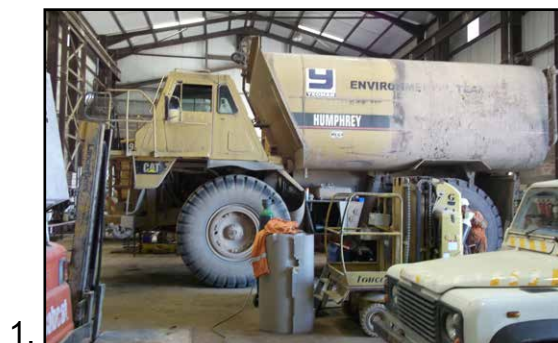
1. Quarry dust suppression bowser in workshop
2. Damage and Corrosion to be repaired
3. Initial application of Belzona® 1111
4. Finished application. Cure accelerated by heat

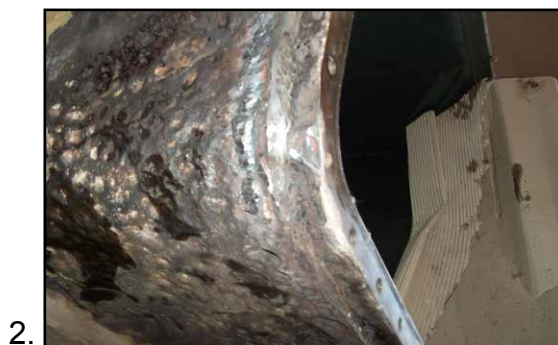
Dust suppression bowser had suffered damage and corrosion to its hydraulic tank causing leakage.

Traditional welding repair had failed to seal the tank. The customer required a fast cold curing solution to bring the bowser back into service.
