BELZONA SOLVES LONG TERM LEAK PROBLEMS AT ELECTRICITY SUBSTATION

Electricity Substation, UK

Exterior/rooftop of Super Grid Transformer HV & LV bushings

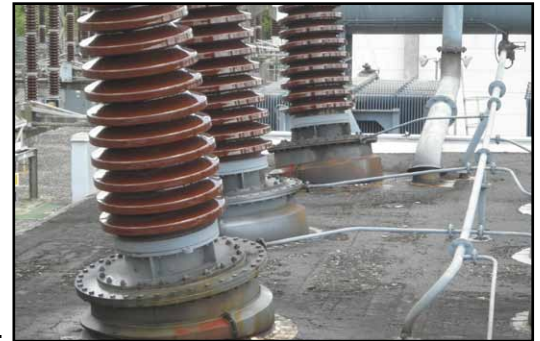
For several years, the transformer had been suffering from extremely high discharges of transformer oil. Following full survey, oil discharges were evident at many of the flange and bolt joints on equipment located in both the interior and exterior of the noise enclosure. A root cause and contributory to the oil leaks were the high voltage and low voltage bushings located to the noise enclosure rooftop.

1. Three HV bushings during survey
2. LV bushing following substrate preparation and masking bolts
3. LV bushing following the removal of one disposable former
4. HV bushing completed including the encapsulation of bolt heads and coating with Belzona 5831 for long term protection
