BELZONA RECHARGES SHUNT REACTOR

Electricity Substation, UK

Shunt reactor 2, located inside the noise enclosure

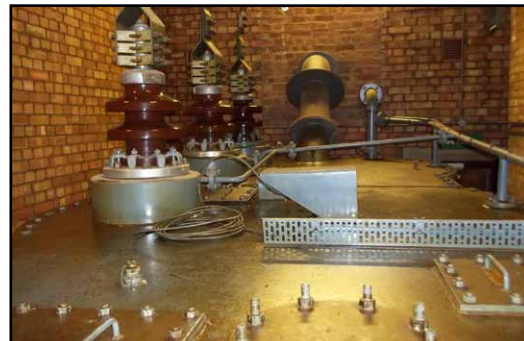
During operation, the shunt reactor temperature can fluctuate significantly together with movement caused by vibration. The Shunt reactor had been discharging transformer oil for many years due to the difficulties in securing maintenance outages. Following a site survey, oil discharges were evident from the bushings and some inspection Hatches.

1. Shunt reactor prior to application
2. Flange joints sealed using Belzona 1161
3. Encapsulation of bolt and nut heads
4. Repair areas coated with Belzona 5831
