BELZONA REPAIRS DAMAGED FIRE ESCAPE STEPS AT SCHOOL

Steel fire escape steps

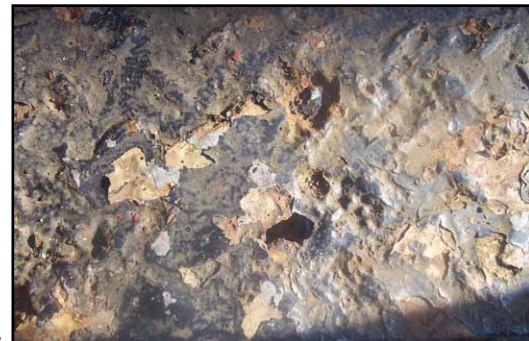
Due to age and weathering the steel plates had become holed and badly corroded creating a safety hazard.

1. Corroded & holed steps
2. Surface preparation
3. Holed steps repaired with Belzona® 1111
4. Completed steps with Belzona® 5811 applied and nosings blinded with Surefoot Aggregate
