BELZONA SHAFT REPAIR AT STEEL MILL

Worn shafts in steel rolling mill

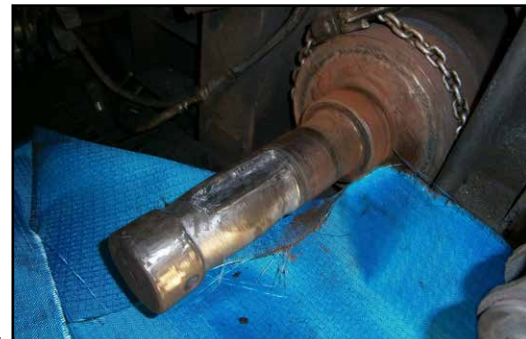
Heavy wear on the drive locations led to excessive downtime for the customer

1. Worn shaft prior to Belzona repair
2. Surface preparation carried out and the bottom former in place on the shaft
3. Former clamped in position and filled with Belzona® 1111
4. Former removed revealing fully cured Belzona® 1111 prior to dressing down
