BELZONA STOPS FLOOR DRAIN LEAKS

Machinery manufacturer, Slovakia

Drain in kitchen floor.

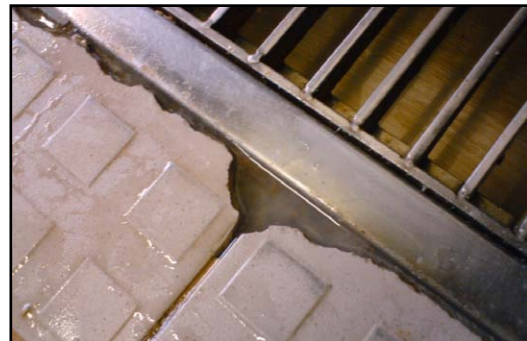
Leakage from the floor drains was problem from the start. Connection between steel and tiles was faulty. Result was the leakage to the next floor.

1. Situation before repair
2. Situation at the floor below
3. Surface preparation being carried out
4. Belzona® 4111 in place creating a watertight seal
