## BELZONA SEALS LEAKS ON SUPERGRID TRANSFORMER

A Super Grid Transformer was Leaking. Such transformers are used on the 400 or 275kV grid.

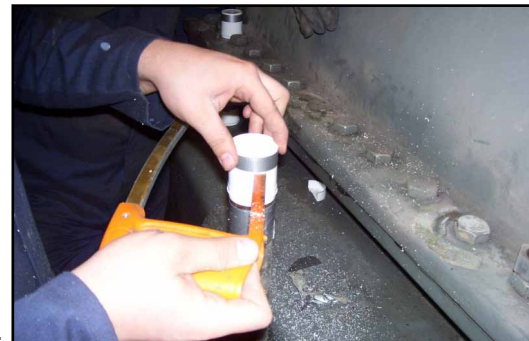
1. PVC pipe being cut into sections to cover bolts
2. Surface preparation using MBX Bristle Blaster
3. The Belzona 1161 encapsulated bolts
4. Completed application with Belzona 5831 applied

Application was carried out using a modified version of Belzona Know-How System Leaflet VPF-11a. after preparing the metal with an MBX Bristle Blaster, Belzona 1161 was then used to seal the bolts using PVC pipe of a wider diameter placed over the bolts and filled with the Belzona until totally encapsulated. Once cured, The PVC cups were cut away so that the entire flange could then be covered with Belzona 5831 to provide overall corrosion protection.
