BELZONA RESTORES PUMP FROM SUGAR MILL

Major Sugar Producer, South Africa

Pump handling Condensate at 80 °C

Customer looking to repair badly eroded back plate & volute and to coat new Impeller

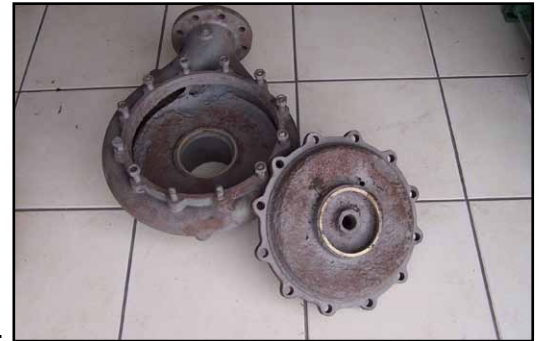
1. Pump after grit blasting
2. Badly worn cut water and hole through volute
3. Finished Application
4. Pump assembled and ready for despatch
