## ABSORBER REPAIRED AND PROTECTED WITH BELZONA

Major chemical manufacturer, UK

Badly corroded throat area in absorber.

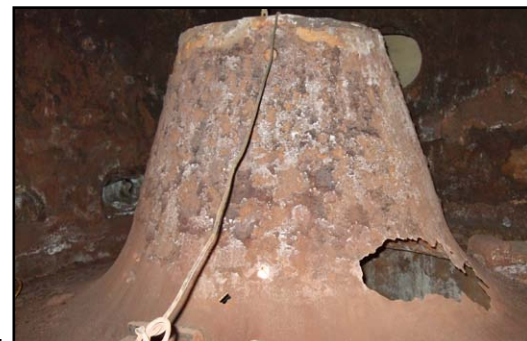
The bubbler throat on the absorber had developed a number of holes within the vessel compartment due to substrate erosion/corrosion.

1. Absorber throat extensively damaged by corrosion
2. Steel plates being bonded onto the absorber using Belzona® 1121
3. Cold bonding completed
4. Completed application with Belzona® 1391 coating applied
