## LARGE GEARBOX RESTORED WITH BELZONA

Steel Plant, Kosice, Slovakia

Large gearbox used in production of steel plate.

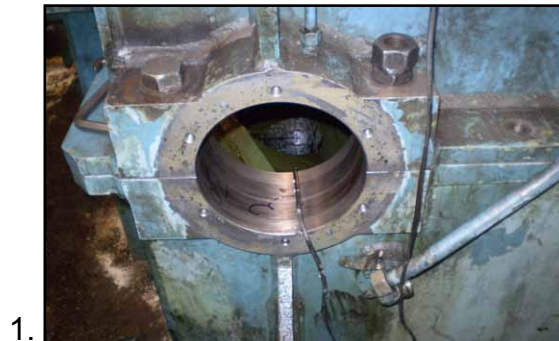
Wear in the bearing housing was causing vibration.

1. Damaged bearing housing before reconstruction
2. Accurate measuring for alignment was a key feature of the process
3. Machining after Belzona application
4. Completed application ready to work

Repairs were completed in accordance with Belzona Know-How System Leaflet MPT-6. Accurate measurements were taken to enable machining to be done in-situ to an accuracy of  $\pm 0.03\text{mm}$ .
