BELZONA REPAIRS EBONITE LINING IN PROCESS VESSEL

Ebonite lined process vessel operating with 10-35% Hydrochloric acid.

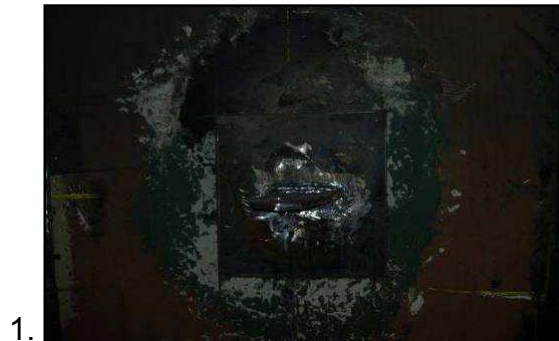
The internal ebonite lining was damaged around the vessel support areas where the ebonite had disbonded leaving the steel exposed.

1. Ebonite lining damaged around support areas
2. Surface preparation completed
3. Belzona® 4301 being applied on the internal supports areas
4. Completed application
