600 M² FLAT ROOF WATERPROOFED WITH BELZONA

Wastewater treatment plant, Rosenheim, Germany

Leaking 600 m² flat roof

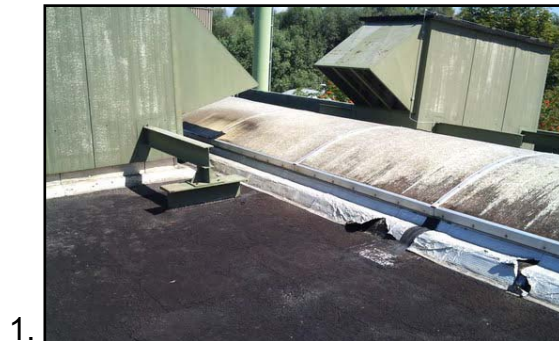
Melt water had regularly leaked through the roof into the hall below as a result of the snow-prone winters in this region.

1. Damaged roofing substrate
2. Application to detailed areas
3. Application in progress
4. Completed application
