## PRESS ROLL REPAIR WITH BELZONA

Pulp and paper mill, Germany

Size press roll from a paper machine.

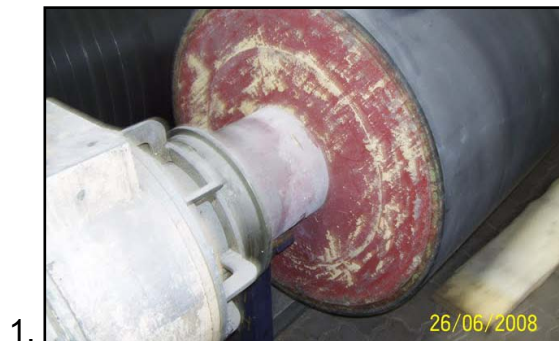
Corrosion had led to perforation of side plates.

1. Corroded side plate
2. Grist-blasted side plate
3. Application of Belzona® 1111
4. Completed application
