THAT'S ONE BIG ROOF APPLICATION WITH BELZONA

Olympic Complex, Algeria

Waterproofing of the Olympic Complex roof.

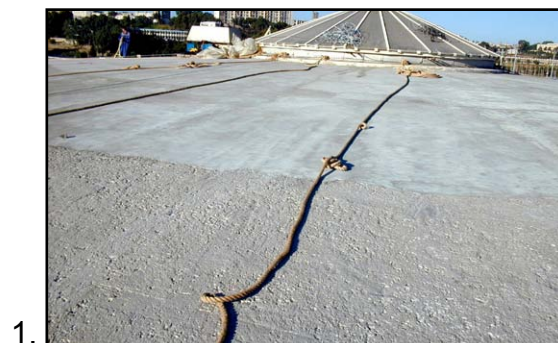
Corrosion and weather damage had caused the 12,000m² roof of the Olympic Complex to leak.

1. Damaged concrete roof
2. Application of Belzona® 3111
3. Completed application in 2003
4. Revisited application in 2009

Application was carried out in accordance with Belzona Know-How System Leaflet RPA-1. Firstly the asbestos coating inside the dome was removed. The roof was resurfaced using a cement based screed to provide a good base for the new coating. A fully reinforced Belzona® 3111 system was then applied.

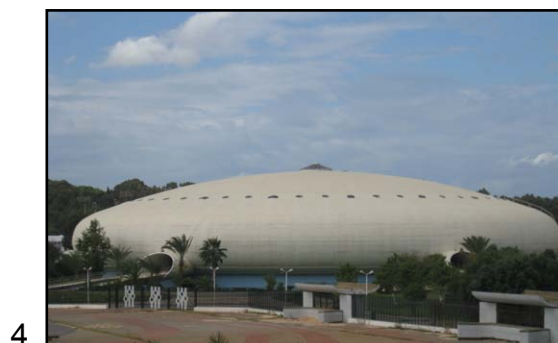
The application was revisited in 2009. After 6 years in service, there was no deterioration of the roof structure. The coating, although covered in dust following a dust storm, was still in an excellent condition underneath. The coating still provided UV-resistance and was watertight.
