COLD BONDING WITH BELZONA OFFERED ALTERNATIVE REPAIR TO PENSTOCK

Hydro Power station, UK

Penstock of the hydro power station (the penstock support was half way up a hill).

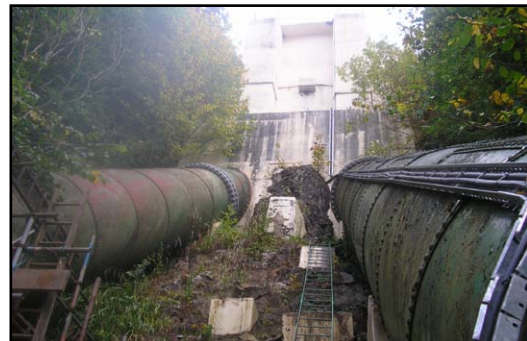
1. View of the penstock
2. View of the pipe support
3. Brass plate being put into place
3. Application completed (Belzona® 1211 on the edges, Belzona® 5811 injected in the void)

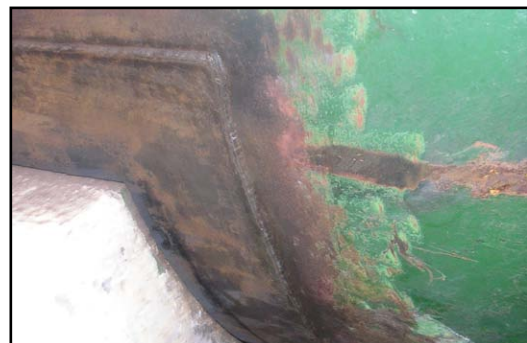
The penstock had been weld repaired and due to the nature of hot works, the penstock had deformed and created a void between the penstock pipe and the concrete support pad. The Hydro power station would not accept the void between penstock and the pipe support and informed the contractor they would need to rectify the problem before signing the job off.
