BELZONA PROTECTS DIGESTER

Water treatment facility, Southern California

Digester producing Methane during sewage treatment.

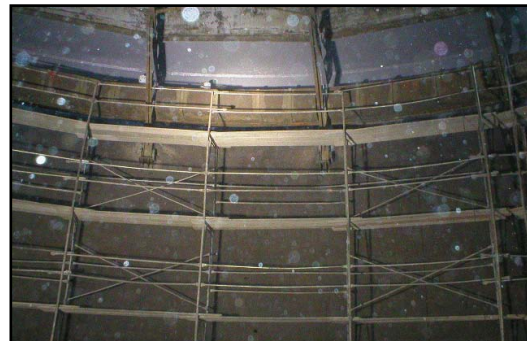
Severe corrosion occurring in vapour space at top of tank on walls and underside of the roof. Also internal pipework being attacked.

1. Top of digester walls coated after grit blasting
2. The pipes waiting to be coated
3. Tank top was also coated with Belzona® 5811

Belzona® 5811 (Immersion Grade)

Belzona was chosen due to the original coating only lasting two years. After careful consideration Belzona was chosen due to its proven longevity in similar service. Application reported to be performing well in 2012.
