BELZONA REPAIR & PROTECTION OF FRANCIS TURBINE RUNNERS

Hydroelectric power plant, Barcelona, Spain

Three Francis turbines severely damaged.

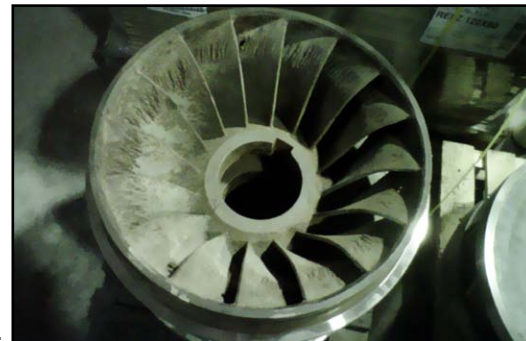
The turbines were suffering from corrosion and erosion cavitation damage in the runner blades which caused holes.

1. Damaged turbine
2. Close-up of the damage
3. Belzona® 1111 used in combination with a metallic mesh
4. Application completed with Belzona® 1341
