BELZONA WATERPROOFS SUNROOM ROOF

Residential Roof in Ontario

June, 2009

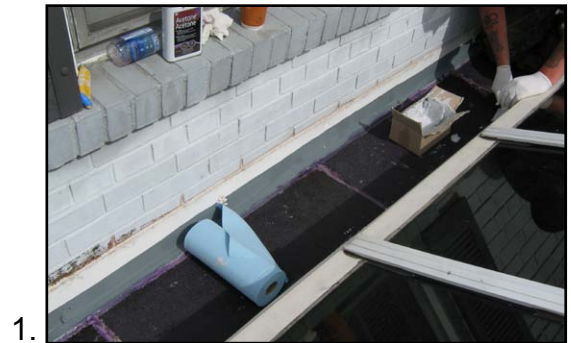
1. Applying Belzona® 3911 (Conditioner)
2. Initial application of Belzona® 3111 incorporating Reinforcing sheet in 1st Coat
3. & 4 Finished application

Using modified Belzona Know-How Systems Leaflet RPA-1, a fully reinforced Belzona® 3111 System was applied.
