## BELZONA REPAIRS DAMAGED CONCRETE AT CIDER PLANT

Cider producer, Herefordshire, UK

Pedestrian crossing at cider plant

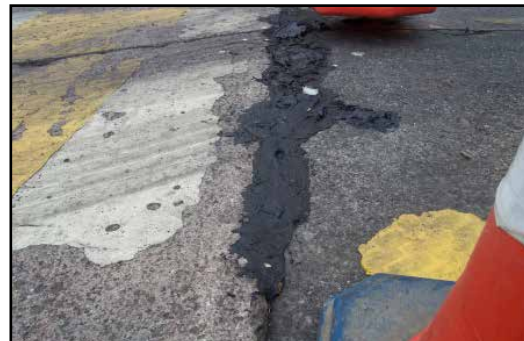
Damaged concrete on walkway was identified as a trip hazard.

1. Previous attempted repair
2. Nosings rebuilt with Belzona® 4131
3. Application of Belzona Elastomer Conditioner
4. Completed application with joint sealed using Belzona® 2211
