FLANGE SEALING WITH BELZONA

Salt producer, Germany

Large leaking flange

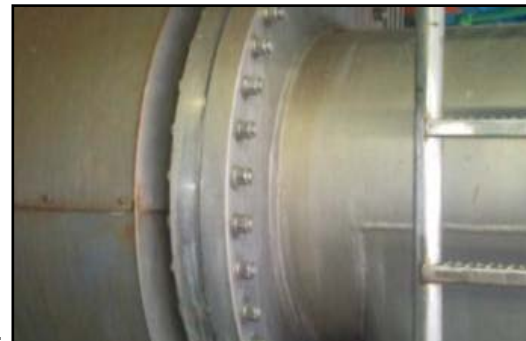
The leaking flange had to be sealed without dismantling as production could not be interrupted.

1. Leaking flange
2. Application of first coat
3. Application of second coat
4. Complete application
