BELZONA SUPERWRAP WATER/CONDENSATE PIPE REPAIR

Major Oil Producer, North Sea, Norway

A six inch diameter pipe, carrying water and condensate, operating at 30-50°C and 31 Bar pressure.

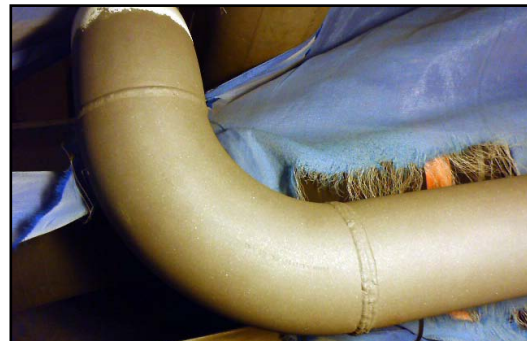
1. Grit blasted pipe prior to repair
2. Reinforcement spirals applied (9 in total)
3. Finished Application (Thickness 33mm, Length 540mm)

A Belzona® SuperWrap reinforced repair, compliant to ISO/TS24817 and ASME PCC-2 Article 4 was designed and applied by validated applicators.
