## BELZONA PROVIDES SOLUTION TO LEAKING HOSPITAL ROOF

Hospital, Leeds, UK

Felt roof over physiotherapy facility within the hospital.

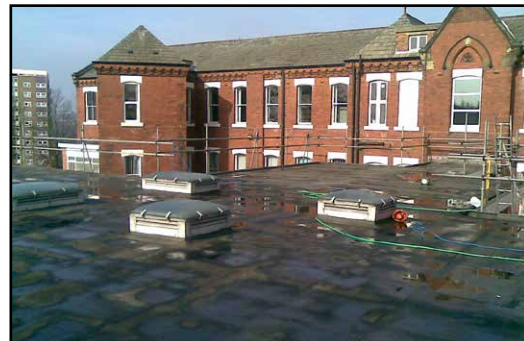
The felt roofing system had become porous over time and was allowing water into the building below. This was causing major disruption to the operation of the hospital as well as posing a health & safety risk.

1. Image of roof prior to application
2. Sealing around skylights and extraction unit
3. Completed application
