THORDON BEARING GLUED IN PLACE WITH BELZONA

Hydro power station, Sweden

Replacement of one of the main turbine bearings.

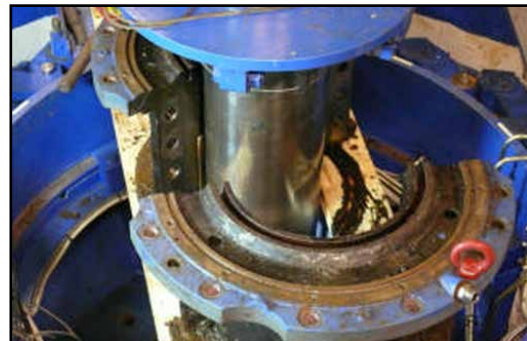
1. Dismantling the bearing housing on the turbine
2. The damaged bearing had disbonded from the bearing housing which resulted in a corroded surface
3. Thordon SXL bearing half mounted and glued with Belzona® 1321. Clamps are used to hold bearing in position

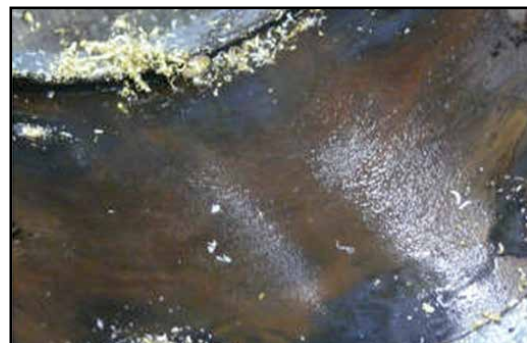
2.

The original bearing was worn out and in need of replacement. The client was looking for effective solution to bond the bearing in place.

Application was carried out using a modified version of Belzona Know-How System Leaflet SHM-7. After grit blasting the bearing housing, Belzona® 1321 was applied to the bearing housing and Thordon SXL bearing before clamping into place until cured. Finally, the bearing was machined down to the correct inner diameter.
