BELZONA REPAIR TO FRANCIS TURBINE END COVER

Hydro power plant, Sweden

End cover of Francis turbine manufactured by KMW in 1939. This hydro plant is one of the main electric utilities in the country.

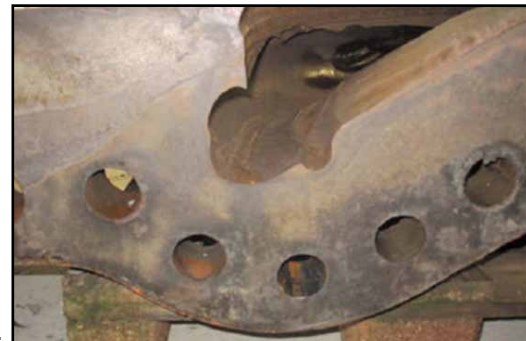
1. One of the end cover halves (there are 4 in total)
2. View of the end cover after surface preparation. Through wall defects clearly visible
3. A former was used to create the original profiles
4. The application of Belzona® 1341 to complete the repair

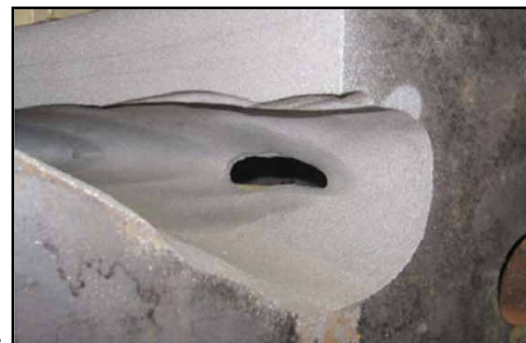
The velocity of the water had led to erosion damage on the end cover of the turbine casing. Several through wall defects were reducing the efficiency of the unit. The end cover was 2.6m wide, 0.2m deep and 1.4 m long

Application was carried out in accordance with Belzona Know-How System Leaflets CEP-3 & 5. The work was done in the contractor's workshop. After preparing the substrate by grit blasting and sealing holes with Belzona® 1291, Belzona® 1311 was applied up to a total thickness of 5-6 cm to restore original profile (100 kg of Belzona® 1311 was used for the repair on the two turbine ends). Finally two coats of Belzona® 1341 were applied to offer erosion protection and to create a smooth finish.
