BELZONA SOLVES WATER INGRESS ISSUE AT UNIVERSITY MACHINE SHOP

University, Manchester, UK.

Courtyard walkway with surface water drain, the source of water ingress into laboratory machine shop below.

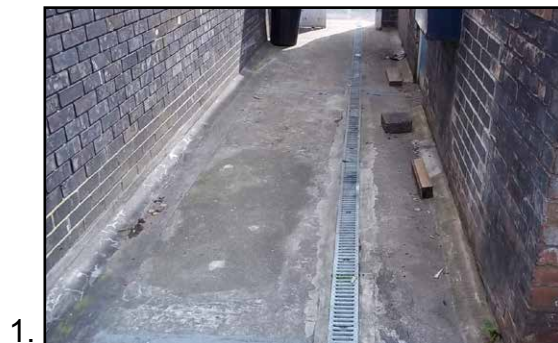
1. Initial inspection of the courtyard walkway and drain
2. Initial inspection of the Lab workshop directly under the courtyard walkway
3. Belzona® 3131 application in progress
4. Completed application
