TANK BASE SEALING WITH BELZONA

Oil Production Company, North East Scotland

108m diameter oil storage tank

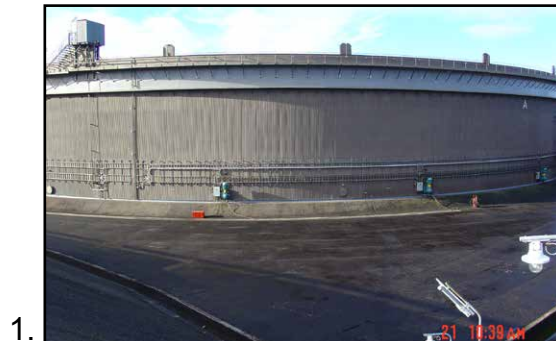
1. The oil storage tank
2. Belzona® 3131 applied
3. Close view of Belzona® 3131 system
4. Belzona 3131 inspected in 2012 still in perfect condition
