BELZONA SAVES COLLEGE BALCONY AND SUPPORTING LINTELS

College, Derbyshire, UK.

Roof area over college technology classroom that is also used as a balcony by the staff

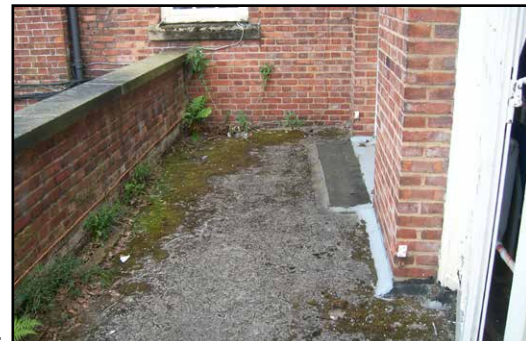
The balcony floor which also acted as a roof area for the walkway below had become porous and had been allowing water to penetrate to the ceiling and into the supporting lintels above the windows. This was causing them to spall quite badly to the point they were at risk of becoming unstable if left untreated. Several previous attempts had been made by others to resolve the water ingress by patch repairs, none of which had proved successful.

1. Balcony floor on first inspection
2. Balcony floor on completion of the Belzona® 3131 application
3. The damaged lintels on first inspection
4. The lintels following Belzona® 4141 repair and subsequent painting
