## BELZONA RESOLVES LEAKY LEAD ROOF AT UNIVERSITY

University, Manchester, UK.

Three Lead covered dormer roofs on top of large University building in the center of Manchester.

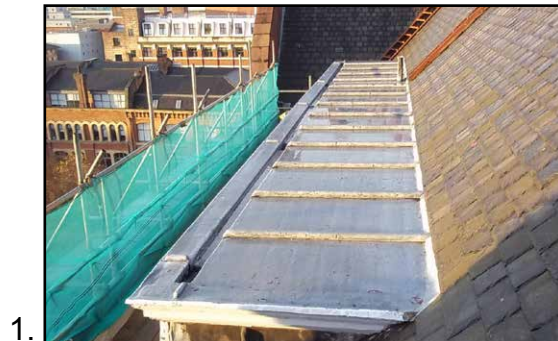
The three lead roofs were allowing water ingress into the wooden panelled ceiling below, under which there was office equipment and a library area. The client required urgent action to make the roofs water tight while not detracting from the lead roof aesthetics.

1. Initial inspection of the lead dormer roofs
2. View of the ceiling below the lead roof area
3. Application of the reinforced Belzona® 3131 in progress
4. Completed application
