## BELZONA BONDS SPADE RUDDER BEARING ON COASTER

Spade rudder bearing on coastal ship.

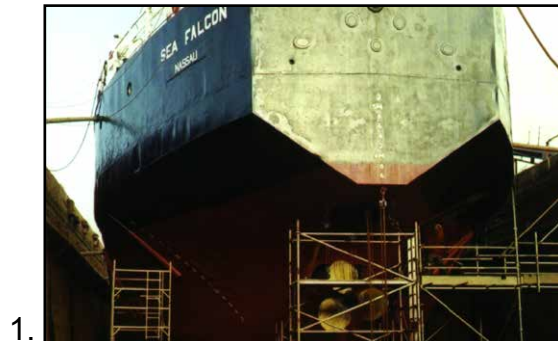
1. Vessel prepared for works in drydock
2. Top of bearing sealed using Belzona® 1221
3. Injection of Belzona® 1321 into the space
4. Completed works. The injection plugs are removed at the same time as the rudder is assembled.
