BELZONA PROTECTS TANK ROOF WITH MINIMAL EFFORT

Petrochemical Plant, UK.

Chemical Tank Roof.

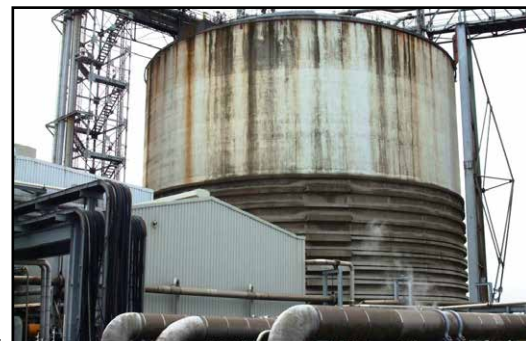
1. Chemical tank of 29m height
2. Corroded domed roof
3. Application of Belzona® 5831 with Belzona® 9211 in the top coat
4. Phase 1 completed
