NOVEL USE OF BELZONA TO SEAL TURBINE HALL ROOF

CCGT Power Station, Runcorn, UK

March 2012

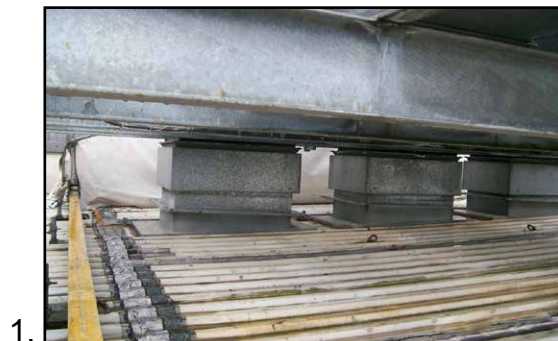
1. General view of turbine hall roof showing Bitumen Flash Band on joints before stripping
2. Close-up of Bitumen Flash Band on joints
3. General view of roof after stripping the joints and sealing with Belzona® 3131
4. Another view of the finished roof joints

To allow turbine removal a knife is run down the joints. The joints are easily resealed with a further coat of Belzona® 3131 and Reinforcing sheet. Belzona® 3131 is easy to apply and lightweight, so procedure can be carried out time and again without detriment to the roof.
