BELZONA OFFERS IMPROVED SAFETY IN CHEMICAL PLANT

Chemical Plant, UK

Concrete damage on roads, bunds and plinths

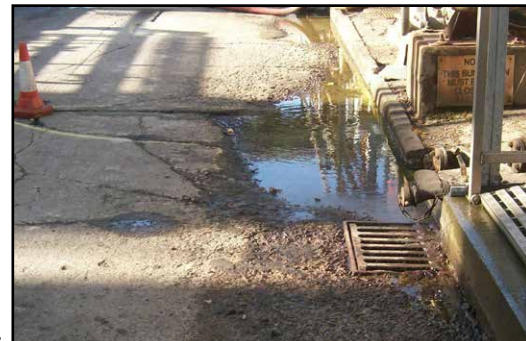
Over many years on this site, concrete surfaces had suffered attack from regular heavy lorry traffic, slab movement and from many chemicals. Concrete surfaces had been cracked or eroded in many areas around the plant, including access roads, pavements, expansion joints, bunds and plinths. Although some of these problems were structural, the main concern for the client was for the trip hazards around the site.

1. Example of typical concrete damage on road
2. Completed repair to road side
3. Completed repair to gulley covers
4. Completed rebuild of forklift ramp
