BELZONA SEALS LARGE BUND AREA

Metals manufacturer, Herefordshire, UK

Chemical bund on large manufacturing site

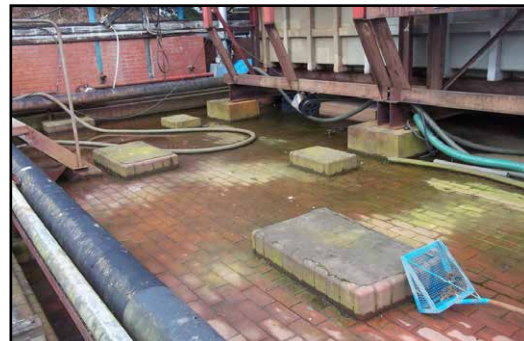
The site regularly test for leaks due to high standards in health and safety and environmental issues. This test showed the bund's brickwork to be leaking from several areas.

1. Before application
2. Creation of fillets at wall/floor joint with Belzona 4131
3. Application of first coat Belzona 5811
4. Completed application
