BELZONA SEALS TRANSFORMER MAIN FLANGE

Super Transformer ST6 located at electricity substation within steel manufacturing plant.

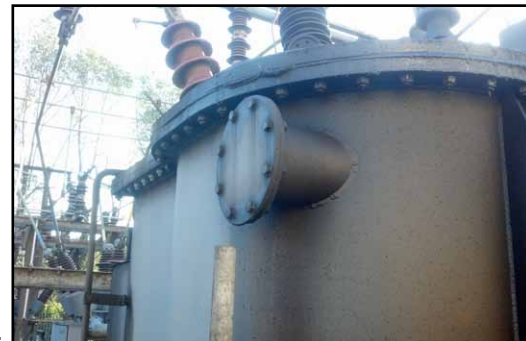
1. Transformer prior to application
2. Close up substrate preparation
3. Main flange sealed and bolt head encapsulation
4. Repair areas completed following Belzona 5831 coating

The main flange was discharging high volumes of oil through the failed gasket system, together with loss through the top and bottom bolt heads. Continual tightening of the bolts was no longer proving effective on this aged transformer. The Client sought a comprehensive solution to seal the main flange and bolt heads.
