BELZONA REPAIRS OIL COOLERS

Ferronickel plant, Macedonia

Four heat exchangers for cooling mill oil.

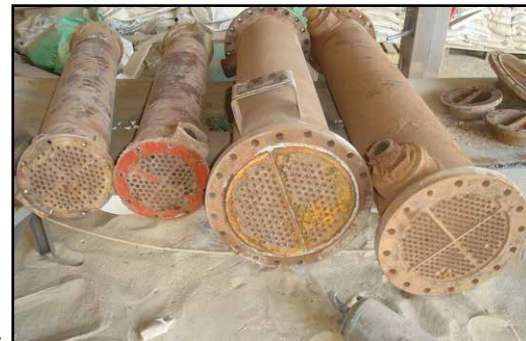
Heat exchangers were suffering from electrochemical corrosion. Gaps occurred between the tube sheet and tubes, causing cooling water to mix with oil.

1. Heat exchanger ready for grit blasting
2. The condition of end cover after blasting
3. End cover repaired with Belzona 1311 and protected with Belzona 1391
4. Tube sheet repaired and protected
