BELZONA PROTECTION TO FLANGE EDGES ON GLASS LINED PROCESS VESSELS

Chemical Plant, South Wales, UK

Glass lined process vessels used in the manufacturing process.

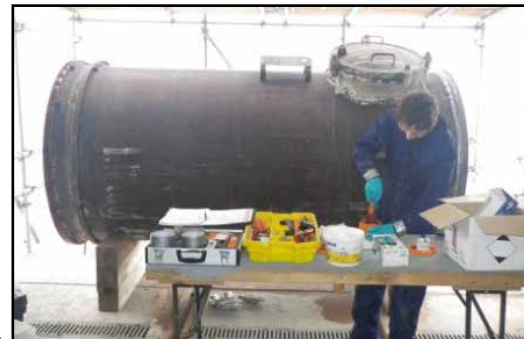
1. Preparation of habitat, product and equipment prior to coating procedure
2. Substrate condition following grit blast preparation
3. Completion of first coat colour coded grey
4. Completion of second coat colour coded red

Application was carried out in accordance with Belzona Know-How System Leaflet TCC-3. Specific attention had to be given to the grit blasting and application to ensure damage was not caused to glass lining. The coating needed to align perfectly to the full circumference of the glass lining in the vessel.
