## BELZONA SOLVES FLAP VALVE DAMAGE

Door Component Plant, Central Missouri

Flap valves used in gypsum/perlite transfer system. The valves were lined with ceramic tile.

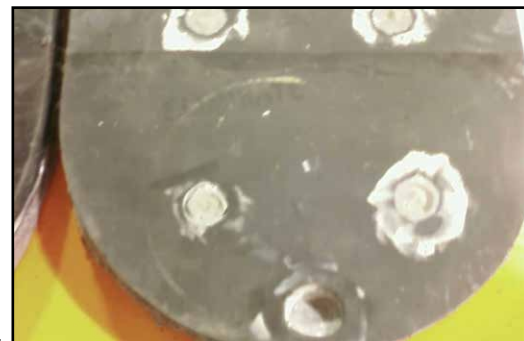
The valves suffered damage on the back of the valve plate due to impact with the valve "stop". This impact would cause breakage/failure of ceramic tiles on the front of the valve, allowing gypsum/perlite mix to cause abrasion damage and prevent valve from sealing upon closure leading to repeated outages of the system.

1. Valve plate showing impact damage on back from striking the valve stop
2. Striker plate and valve plate prepared for application
3. Striker plated bonded to back of valve plate with Belzona® 2111
4. Ceramic tile repaired with Belzona® 1812 on one valve, tile replaced with Belzona® 1812 on second valve

Application was carried out in accordance with Belzona Know Show System Leaflet SHM-7. Belzona® 2111 was used to bond a stainless steel striker plate to the back of the valve plate to absorb and distribute the sharp point impact from the valve stop. Belzona® 1812 was used to repair valve with broken tile and ultimately replace tile altogether for abrasion resistance on front of valve.
