## BOW THRUSTER REPAIR WITH BELZONA

Bow thruster of cargo vessel

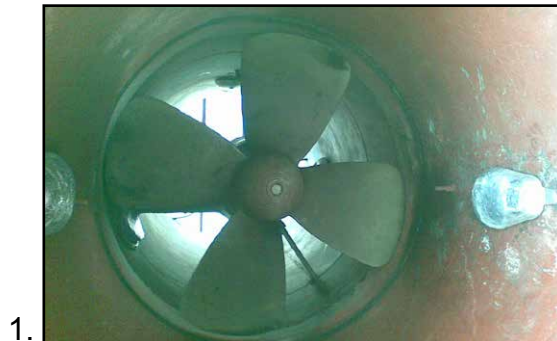
Erosion/corrosion effects made severe pitting damage to the whole bow thruster and supporting pillar due to bad cathodic protection.

1. General view of bow thruster
2. Belzona® 1311 used to rebuild damaged surface and restore profile
3. First coat of Belzona® 1321 applied
4. Second coat of Belzona® 1321 applied to complete application
