VACUUM PUMP RESTORED WITH BELZONA

Sheet metal factory, Casablanca, Morocco

Liquid ring vacuum pump used in metal processing

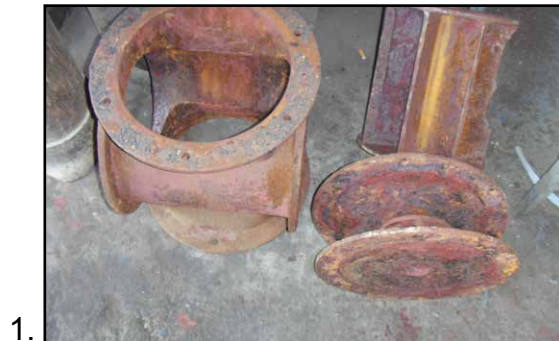
Corrosive fumes had caused severe corrosion on all parts of this vacuum pump.

1. Original stator and end covers
2. Original rotor
3. Completed application on the stator
4. Completed application on the rotor
