BELZONA RELINES WATER PUMP

Water treatment Plant, Stavanger, Norway

Worthington pump used in water/waste water treatment.

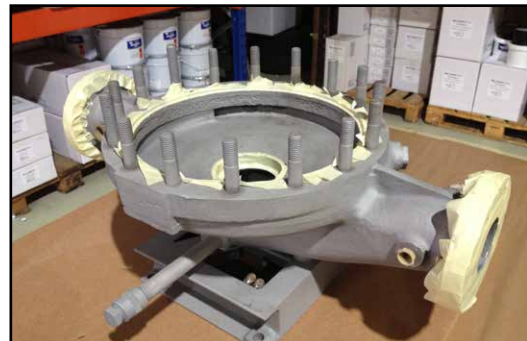
The pump was suffering erosion/corrosion after 3 years in service due to total breakdown of existing unknown coating.

1. Grit blasted pump prior to application
2. Rebuilding internal damaged areas
3. Finished application
4. Pump and parts coated internal and external prior to return to client

Application was carried out in accordance with Belzona Know-How System Leaflets CEP-3 & CEP-5.
