BELZONA UPGRADES SAFETY AND APPEARANCE OF SCHOOL ENTRANCE

Secondary School, Port Talbort, South Wales

Steps leading to school main entrance

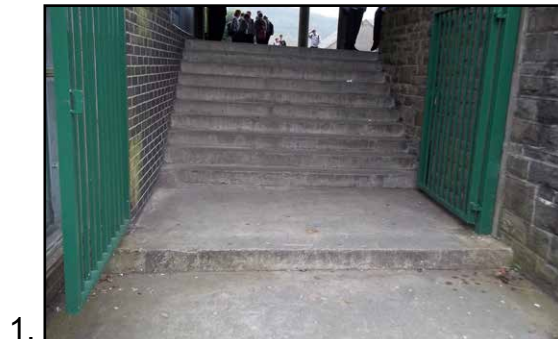
Step nosings had become damaged and overall very dirty. The school wanted the main entrance upgrading and wanted to ensure the steps were safe for its staff, pupils and visitors.

1. Deteriorating steps at the entrance to the school
2. Repair to steps using Belzona® 4111
3. Application of Belzona® 5231 overall
4. Complete repair with Belzona® 4411 grip system applied to the step nosings.
