BELZONA SAFETY GRIP SYSTEM ON STAIRS

Manufacturer, UK

July 2012

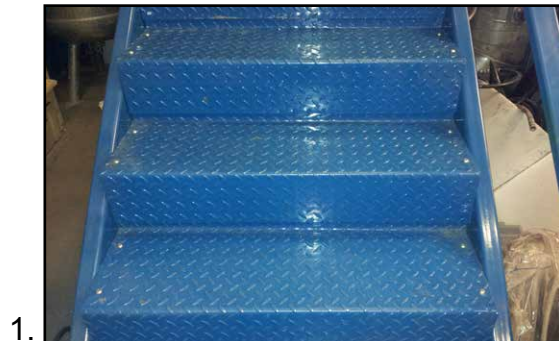
1. Steps before Belzona Application
2. Abraded and Masked steps
3. Half of steps completed
4. Completed application

A potential slip hazard was identified on the metal stairs.
