BELZONA INSITU RESTORATION OF SHAFT IN WASTEWATER PLANT

Water treatment plant, Fayoum, Egypt

Damaged shaft on rotary filter at wastewater station

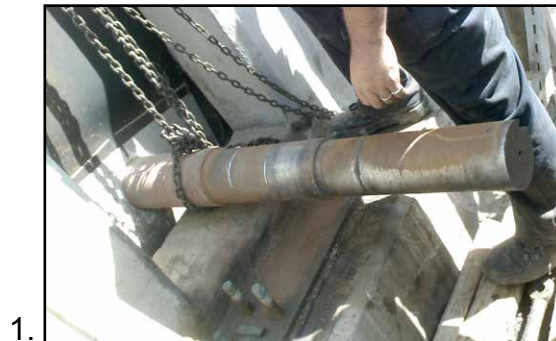
Shaft had become worn and needed insitu repair.

1. Worn shaft
2. Former treated with Belzona Release Agent
3. Application with split former in place
4. Former removed and shaft ready to be returned to service
