BELZONA EXTENDS THE LIFE OF SWIMMING POOL FILTERS

Swimming pool, Canada

Filter units for a swimming pool.

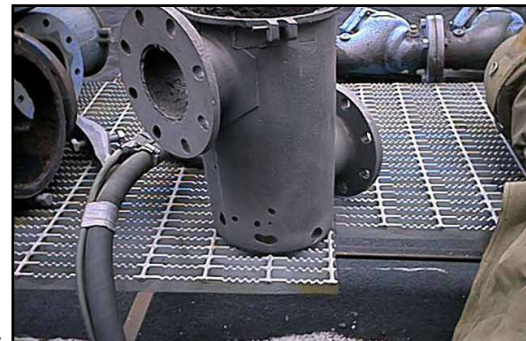
The filter pots had corroded through in various places. Due to the age of the unit direct replacement not available so replacement of the filter with a new unit would be both expensive and complicated, requiring re-design of pipework.

1. Condition of unit after blasting showing holes in bottom
2. Eroded sealing flange
3. Rebuilt unit coated with Belzona® 1321 on the inside and Belzona® 5811 on the outside. Note reformed sealing flange face.

Application was carried out in accordance with Belzona Know-How Leaflets VPF-1 and VPF-2. Plates were bonded over holes and faired with Belzona® 1311 before internal surfaces were protected with Belzona® 1321 and externals with Belzona® 5811. Sealing faces were also modified to improve seal.
