BELZONA PROTECTS GAS SEPARATOR FROM PITTING CORROSION

Natural Gas Plant, South West China

Feed gas liquid separator

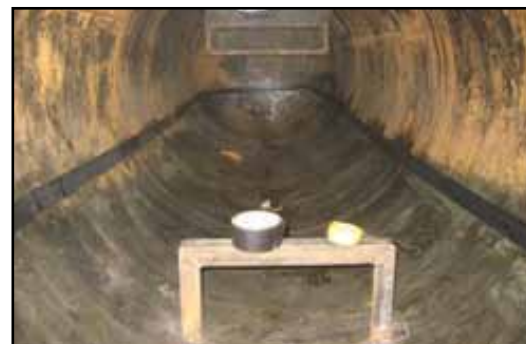
Severe pitting corrosion in the internal wall of the vessel due to presence of sour gas.

1. Internal wall of the vessel before application
2. Pitting corrosion in the wall
3. Completed application
4. Inspection after 6 years

The application was carried out in accordance with Belzona Know-How System Leaflets TCC-5. Areas of severe corrosion and pitting were identified and repaired using Belzona 1111 and then coated with Belzona 1321.

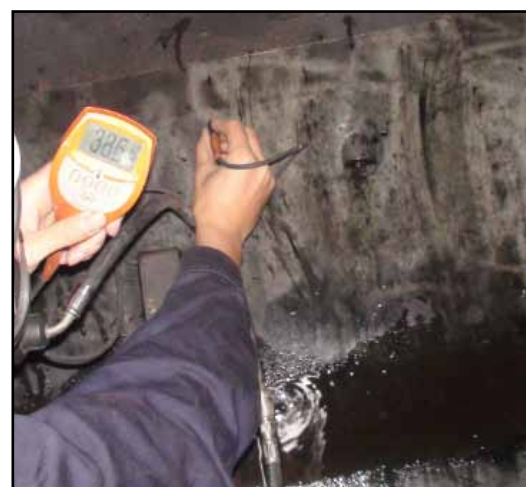
4.

By using the Belzona solution, the corroded areas of the separator were repaired and protected from further corrosion. The vessel has been operated with H₂S present for a further 6 years without defects being found.
