BELZONA REPAIRS WASTE WATER SLUDGE TANKS

Sludge treatment site UK

May 2013

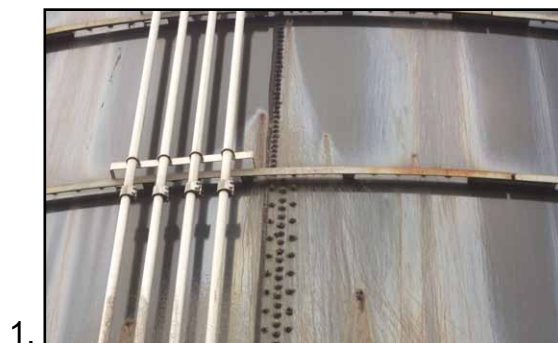
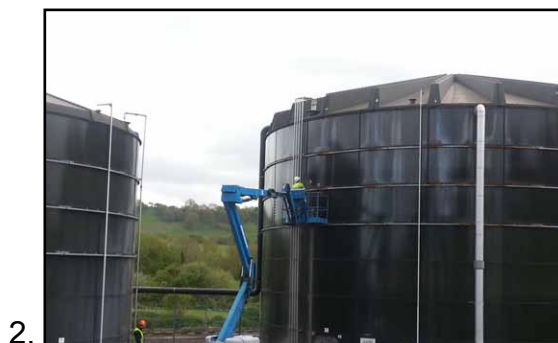
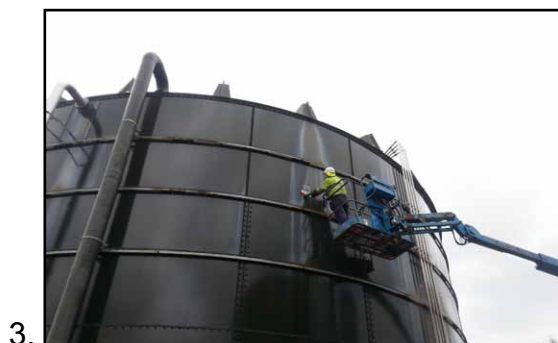
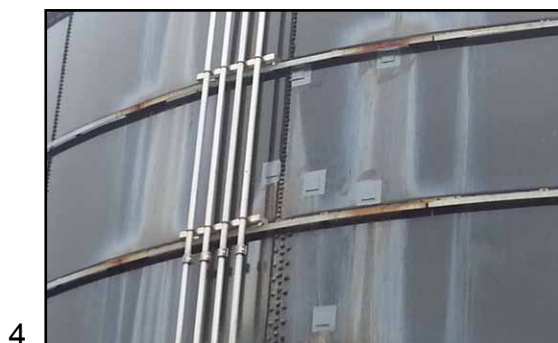
PICTURES

All three tanks were suffering from through wall corrosion at the vapour interface level. The tanks could not be taken off line due to demand and any repairs would have to be carried out without hot works or the use mechanical equipment due to the risk of sparks.

1. Transformer bushings
2. Ceramic insulator after abrading with Dremel and cleaning
3. Ceramic insulator and bushing masked off
4. Application completed

The application was carried out in accordance with Belzona Know-How System Leaflet TCC-3. After cleaning the areas surface preparation by hand abrasion was carried out. Repair plates pre-coated with Belzona 5831 were cold plate bonded over the through wall defects using Belzona 1161 finally Belzona 5831 was applied to the entire repair areas.
